# Environmental Restoration in the Paxtang Parkway – A Preliminary Action Plan

Scott Shepler, CAGA, and Todd Moses, Environmental Restoration Specialist
December 2015

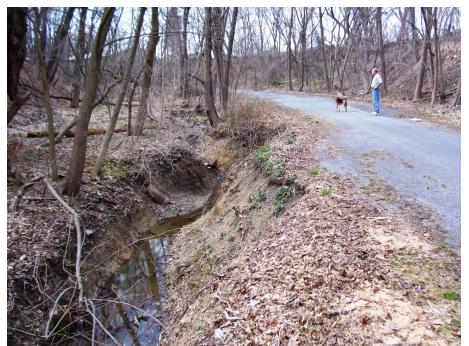
Serious stream erosion is currently occurring throughout the entire Parkway but the eroding channel has now closely encroached on the old roadway (henceforth referred to as the 'trail') in three separate locations. Erosion at these locations is not only unsightly and unsafe, but ultimately threatens the sanitary sewer line embedded within the old road embankment. Accelerated erosion of the high, steep streambanks typical of nearly the entire length of the stream within the Parkway is also releasing large quantities of sediment to the main channel of Spring Creek (which still supports a wild trout population) and, ultimately, to the Chesapeake Bay. Stabilizing the stream

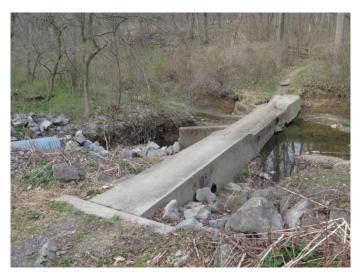
There are at least three sites along the valley floor where sanitary sewer crossings are at risk of failure due to erosion. In the case of the crossing illustrated on the right, the concrete-encased pipe may have always been a dam (as evidenced by the culverts) but this has now become seriously compromised by continuing stream erosion. The existing 'leaky' dam is actively being undermined and this, along with pipe weathering, will inevitably result in the failure of pipe in the relatively near future.

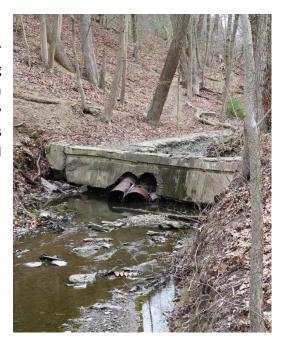
Another exposed and eroding sanitary sewer crossing of mainstem Paxtang Tributary (pictured on the left) was also fully exposed when constructed but is now being flanked by erosion along its margins and is also being undermined. There is a third exposed sanitary sewer pipe bridging a

smaller tributary stream between these two mainstem sites which is also at risk. All three sites need to be repaired soon to ensure that no spills occur and that the vital sanitary connections are not disrupted during a large flood.

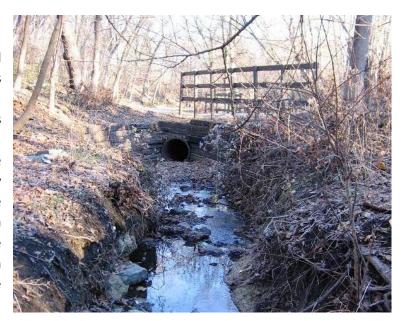
This Phase 3 project would address erosion and flood capacity issues at the three road crossing locations where the mainstem is pinched down and routed through a culvert. One crossing may be removed as part of the Phase 1 design since it is on a stub road that has been abandoned and can be removed. The other two culverts must remain as crossings since they carry creek flow under the main trail. These should be replaced with either much larger capacity open-arch culverts or with bridges. (Undersized culverts are always prone to debris plugging during floods in forested areas, with this often resulting in massive erosion during really large storms.)

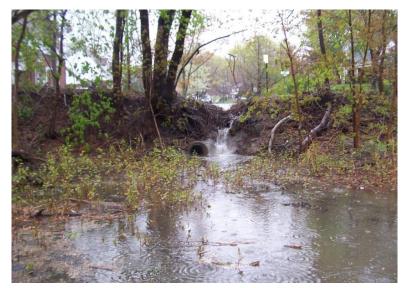
Good examples of undeveloped sites with great GSI potential are located between the trail and Park Terrace, a residential street along the southern part of the Parkway. The wide trailside depressions here receive surface runoff and piped drainage from the adjacent residential area (see photo on the left). Although these depressions are currently loaded with sediment derived from these runoff sources, they can potentially be deepened and converted into rain gardens, which are GSI facilities which both biologically treat urban contaminants in runoff and temporarily store stormwater, allowing all or most of this to infiltrate before direct release to the stream.
